STS-111 PRE-LAUNCH PAD DEBRIS INSPECTION REPORT
KSC Debris Team
4 June 2002

The pre-launch inspection of the MLP-1, Pad A FSS and RSS was re-performed on 4 June 2002 from 1700 to 1900 hrs EDT.

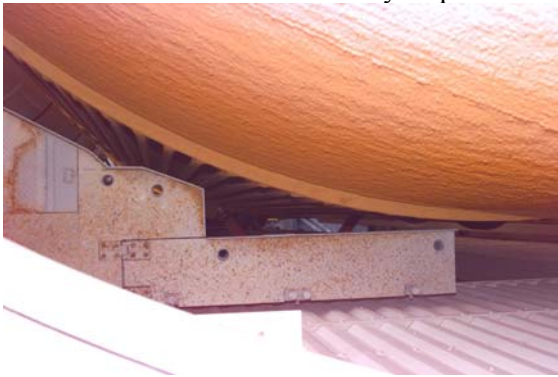
- -Y ET access platform flip is in down position. This flip needs to be raised prior to RSS retract. The end of the platform is within 3.5 inches of the External Tank. This item was identified in the first L-1 Day inspection on May 29 and was not corrected.

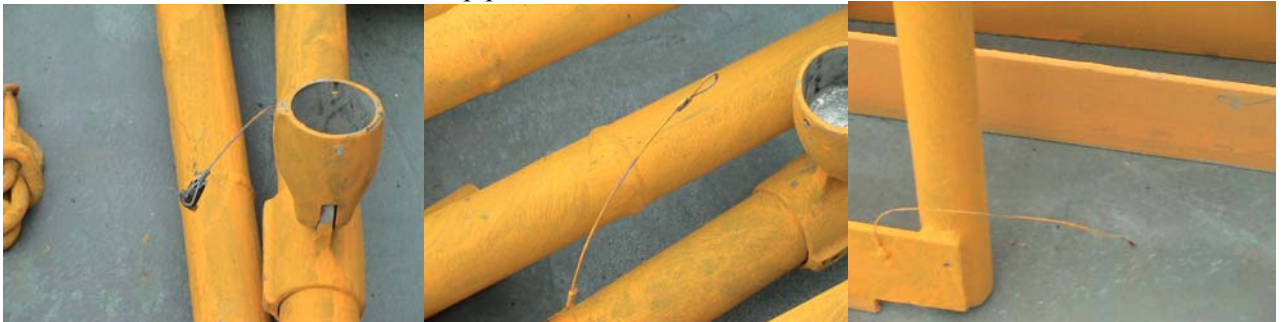
- Excessive sand/debris on MLP deck and in gutter around MLP zero level.
- Two missing (handrails S2-16 and P4-1) and one broken pip pin (handrail S4-16) from removable handrails around the SRB exhaust hole. The handrails were already removed and were situated on the MLP deck. Pip pins need to be accounted for.
